Storm Sewer System Evaluation

Prepared for
City of Ionia

September 2019

2130311

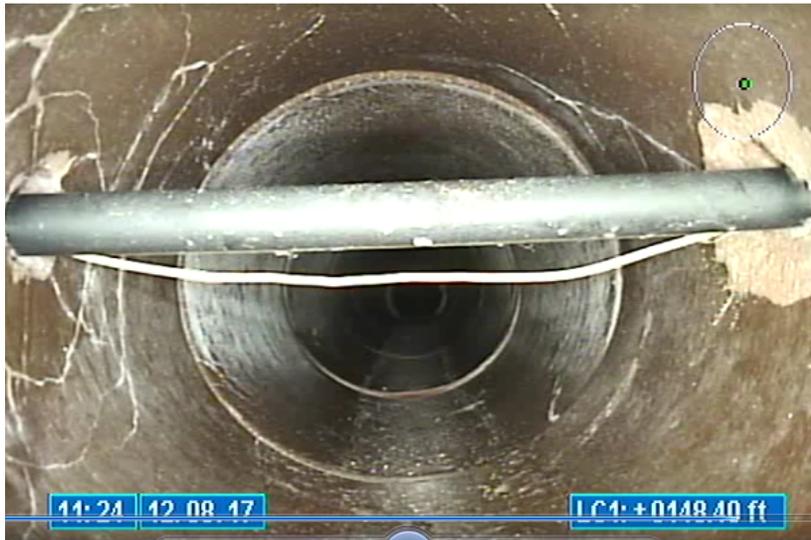
| Location | Upstream MH | Downstream MH | Distance | Description | Status* |
|---|---|---|---|---|---|
| King St. | CB-406 | CB-408 | 19 ft N of CB-408 | black pipe | existing |

King Street north of Hackett St.
CB-406 to CB-408
Utility penetration

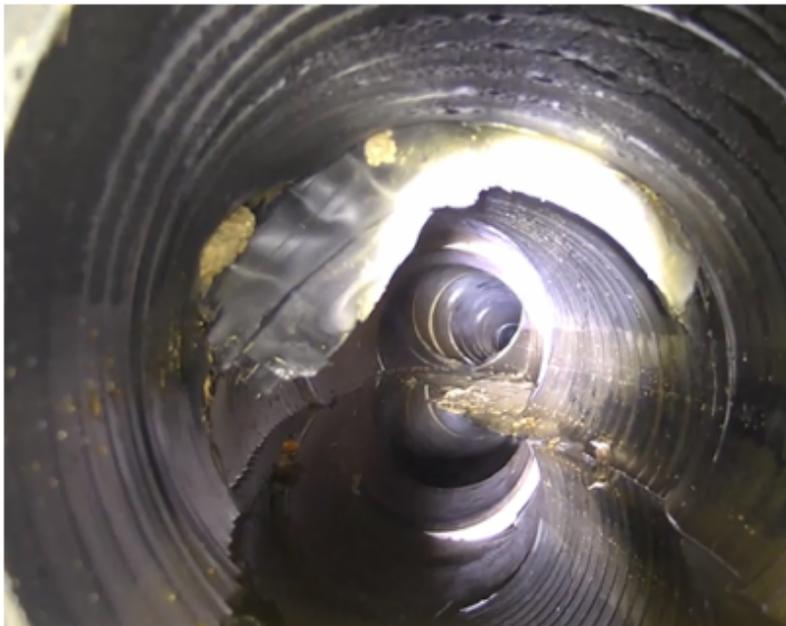
Main St. northeast of VanderHeyden Ct.
MH-176 to outfall
Broken

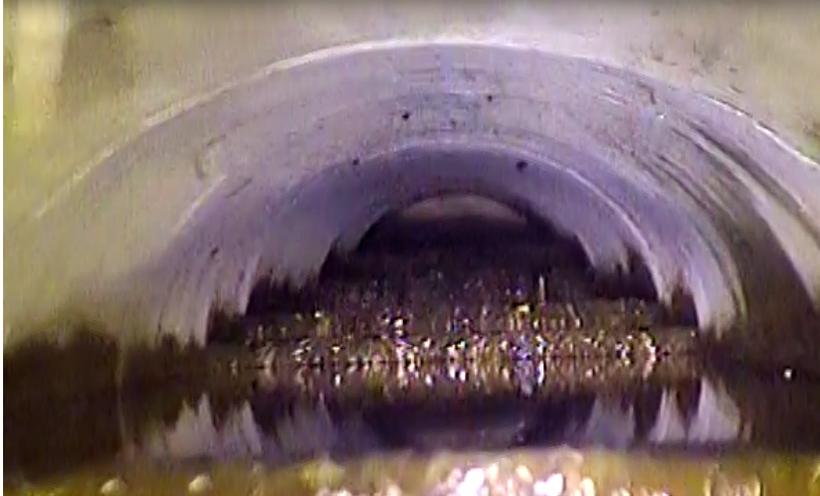
Flow blockage of 50% to 75% of the pipe capacity was found in the storm sewer on Main Street between Library and Rich. The blockage appears to be concrete that was poured into the storm sewer and cured in the pipe. Due to the large amount of concrete, removal by jetting does not appear feasible. Construction of a parallel overflow storm sewer is recommended to allow for stormwater conveyance with minimal construction within the Main Street brick pavement.

Main St. west of Steele St.
MH-90 to MH-89
Concrete obstruction in pipe

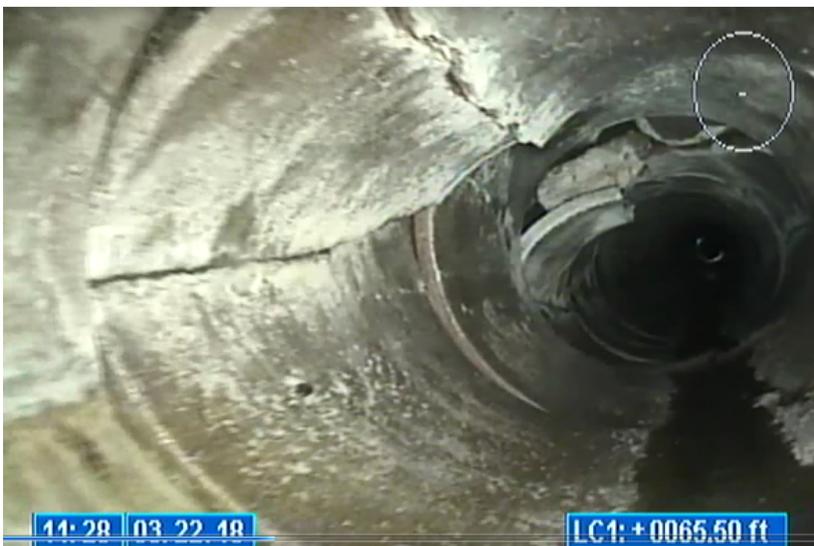
Cross country pipe south of M-21
MH-212 to outlet
Broken

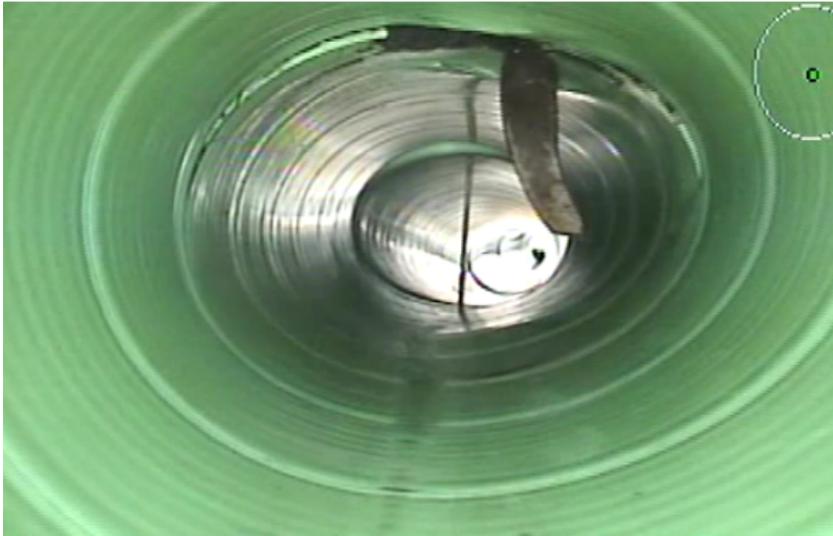
Forest at Lawton
CB-462 to outfall
Deformed, cracked, and metal intrusions in pipe
