Storm Sewer System Evaluation

Prepared for
City of Ionia

September 2019

2130311

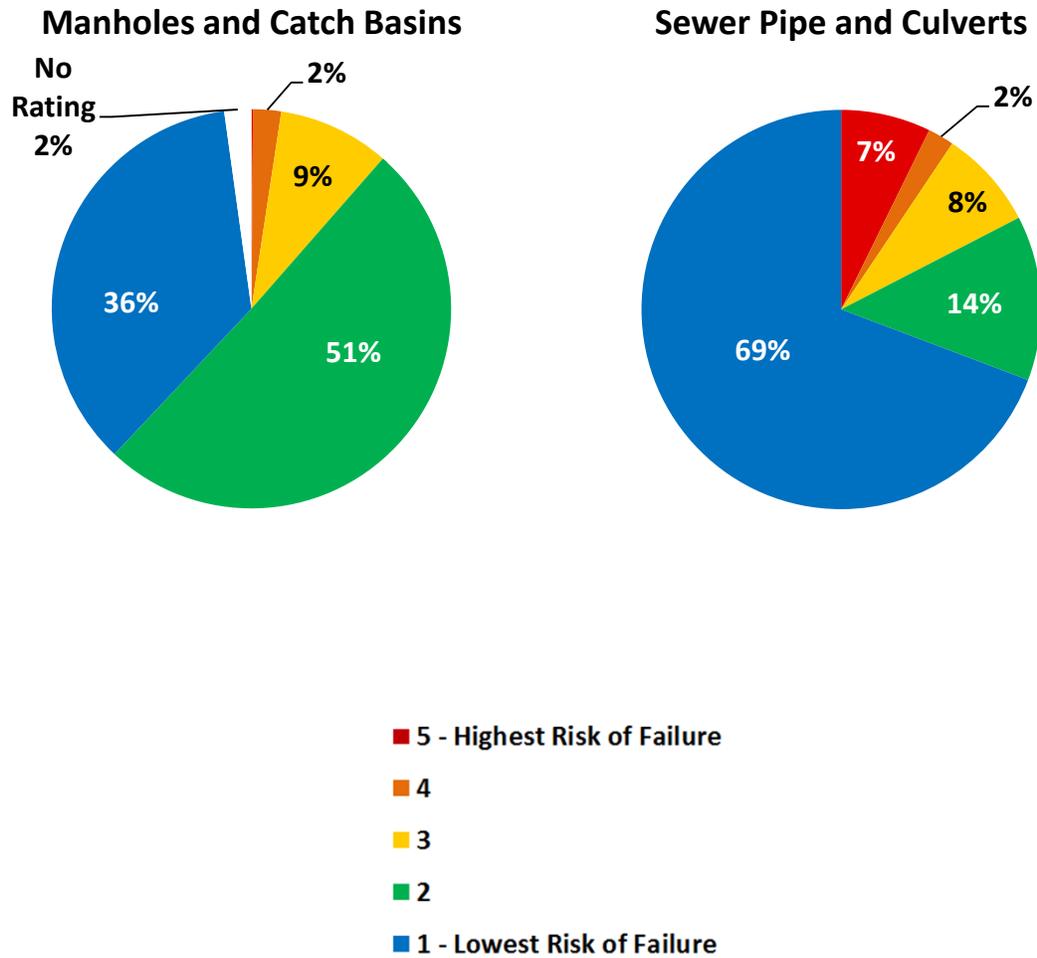
Risk of Failure Rating Summary

RoF ratings for sewer pipes and culverts are shown on Map 6A and manholes and catch basins on Map 6B. RoF ratings are summarized in Figure 3. The majority of these assets have a relatively low risk of failure in their current condition. However, the pipes with the highest RoF ratings are already experiencing structure failures that will need to be addressed.
